## Effect of Excavation Dewatering on Adjacent Structures

**Magdi M. E. Zumrawi, Elhaytham Hassan**

**Abstract:** The study aims to investigate the effect of dewatering technique on retained ground and adjacent existing structures in order to avoid any damages that may occur. The paper presents three cases of potential structure failure caused by ground settlement as a result of dewatering. Two current construction projects in Khartoum North were selected as a case study. The two projects are located near Blue Nile River where ground water table exists at shallow depths. Dewatering to reduce the groundwater level was carried out in the two sites to facilitate excavation works. The buildings and road pavements around the two sites suffered serious damages due to excessive differential settlements of the retained ground. The study results showed that there are numerous sources of risks associated with performing dewatering. Therefore, developing appropriate plan for dewatering before construction is essential to mitigate any adverse impacts and avoid risks.

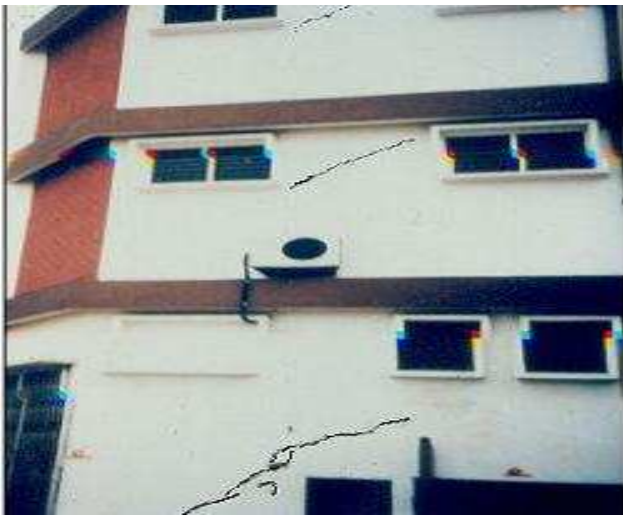
As observed at the site, the final excavation level was mainly at the sandy layer. Dewatering activity within the excavation pit was carried out to facilitate the construction of basement slabs and pile caps. The shop houses around the excavation site had cracked due to excessive differential settlement of the ground. Other than cracks on the brick walls, cracks were also observed on the reinforced concrete beams and columns. On one of the units, the structural cracks were so severe that the structural integrity of the house came into doubt and was declared unsafe for occupation (**Fig. 5**).

**Fig. 5.** Severe cracks in the external walls of a house, [14]

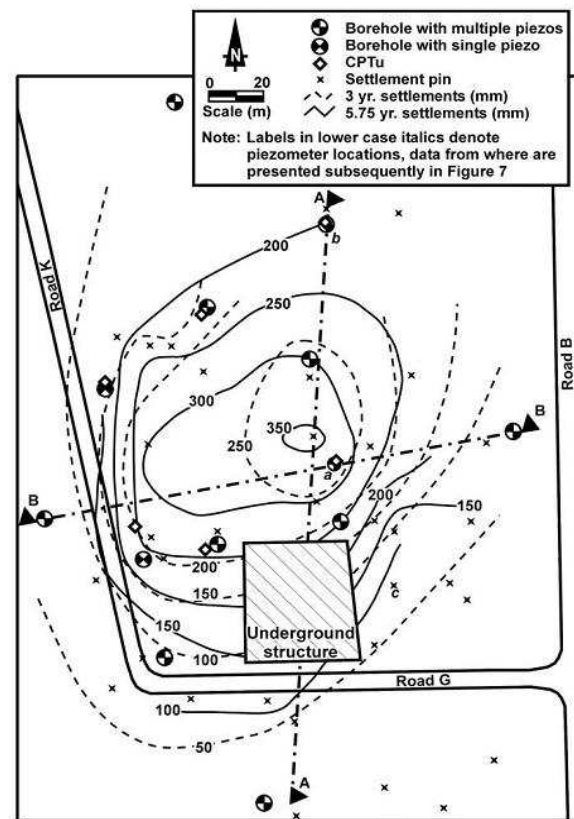
Permanent dewatering for the underground structure resulted in settlements as large as 360 mm within 5.75 years of construction completion. The area affected by settlements extended to distances as far as few hundred meters beyond the perimeter of the structure skewed to the North as shown in Fig. 6.

**Fig. 6.** The project site layout and settlement contours, [15]

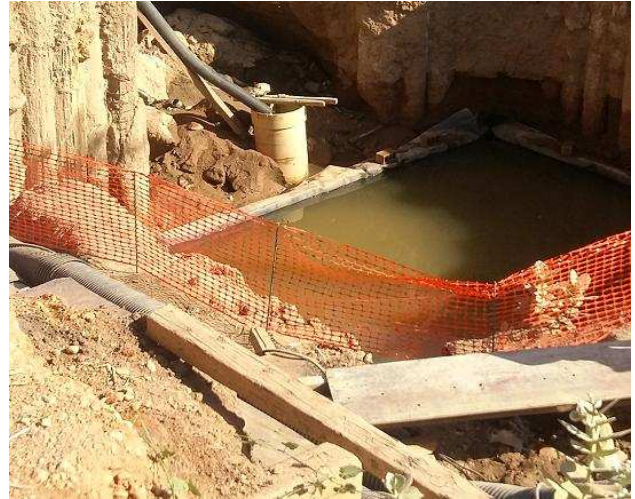
The construction of the station started in 2013 with deep excavation. The contractor started to excavate for the foundation and when the excavation reached close to 7m depth, water started to appear from all directions, filling the site and erode the sandy silt layer at that level creating cavities at excavation sides as shown in **Fig. 7**.

**Fig. 7.** Water filling the site and erode the excavation sides.

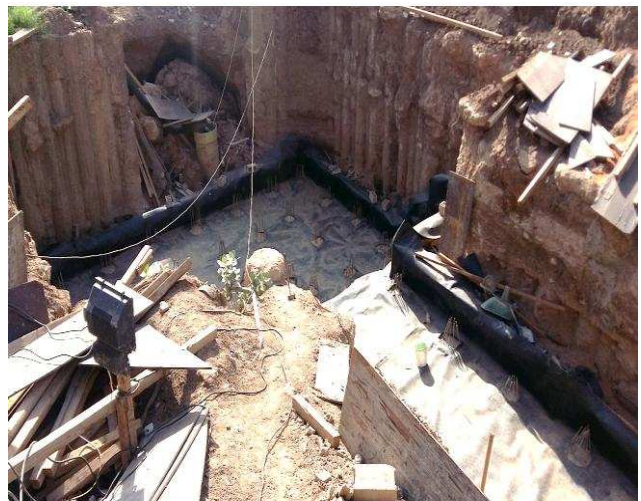
To stop water flow, the contractor started dewatering by pumping water from the excavation pit. Due to presence of sandy silt layer at the excavation sides, earth masses had been sheared and fall down and large cavities created as a result of dewatering (**Fig. 8**). Pumps continuously worked to withdraw water from the site in order to facilitate excavation works. Sever cracks and damages due differential settlements were clearly observed on the adjacent buildings and road pavement as shown in **Fig. 9**.

The possible causes of the critical situation of the site and the problems resulting from dewatering revealed that no detailed design of dewatering system is used. Inadequate control for ground water level during excavation resulted in sliding and failure of the earth sides; no support is used for the deep excavation like sheet piles to protect the sides from failure; and cavities created in soil layers due to dewatering are a complicated problem which needed making plans before starting any works.

**Fig. 8.** Falling down of excavation sides after dewatering

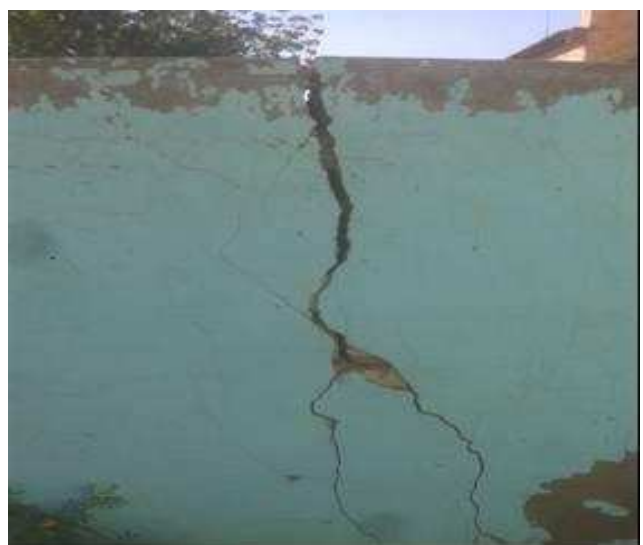
**Fig. 9.** Serious cracks in walls of adjacent buildings

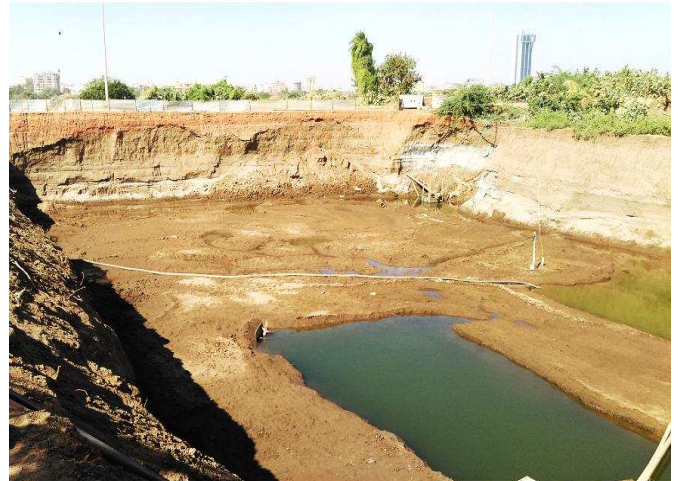
During the basements excavation, water appeared at a depth of 5.3 m below ground level and started to fill the site as shown in **Fig. 10**. The contractor had to start pumping the water in order to continue the excavation work. Sump pumping system was installed to withdraw water by dewatering.

**Fig. 10.** The project site filled with water before dewatering

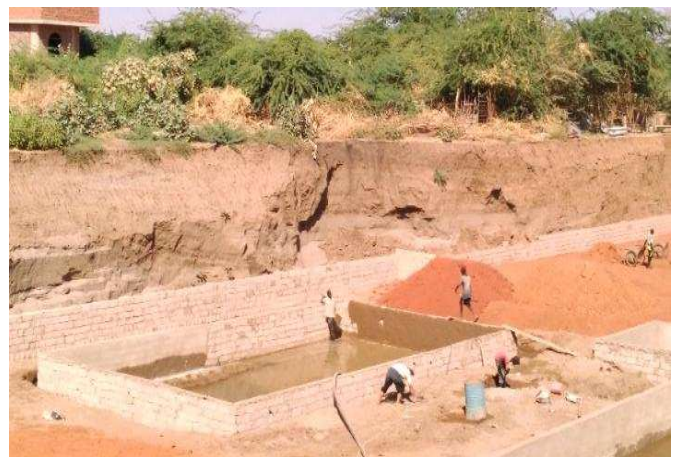
Sliding of the excavation sides of the sand layer was clearly observed on the north and west sides. The contractor used bentonite in some areas of big sliding, but still falling. Large cavities and damaged earth sides were observed after dewatering (**Fig. 11**). The possible causes of these problems at the site may be due to ineffective dewatering system used and excavation sides were not supported to protect them from sliding failure.

**Fig. 11.** Sliding failure of the excavation sides created large cavities
