A Study on Scour Failure at Bridge Foundation

Magdi M. E. Zumrawi¹, Hassan A. Abusim²

^{1,2}University of Khartoum, Faculty of Engineering,
Department of Civil Engineering, Khartoum, Sudan
(E-mail: magdi.zumrawi@yahoo.com, E-mail: hassan.abosum@gmail.com)

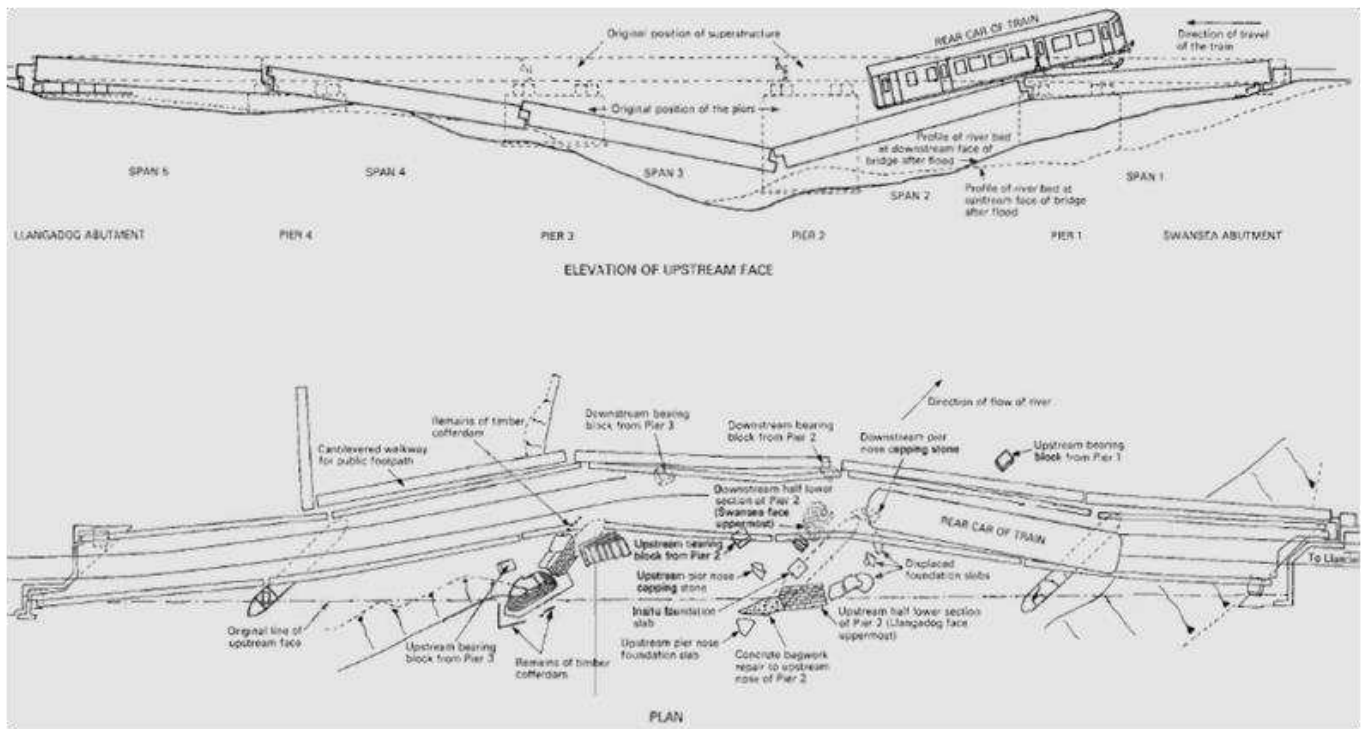
Fig 2: Sketch of Glanrhyd Bridge failure [19]

The collapse mainly caused by the scour at the downstream end of pier number 3 that undermined the foundations, allowing the pier to settle and eventually break its back as shown in Fig. 2

The report showed that the pier was originally constructed by driving timber piles to form a cofferdam, making a base for the bridge foundations within the cofferdam of cemented river gravel and then placing stone foundation slabs. Many of the timber piles were missing and this had allowed the undermining to progress below the foundation slabs.

A study of the river flow found that there was a re-circulating zone or eddy at the downstream end of pier 3 and up to 17000 tons of the sediment may have passed the bridge during the three hours of peak flows, indicating a major live bed scour with both erosion and deposition at the bridge. The depth of any anticipated scour at pier 3 could have been between 0.75 and 2.2m depth. It seems that local scour at the downstream end of pier 3 was the main cause of the collapse. Moreover, the remedial works previously carried out to defective bridge piers increased the likelihood of scour damage because the piers were widened and the shape of the cutwaters was changed. Nevertheless, there is the investigators concluded that prior to the collapse there were no visual indications that the bridge stability was in danger.

The past arrangements whereby bridge superstructures were replaced without any check being made on the existing foundation construction to be unwise. The bridge severed from damage to the various parts of the steel superstructure of the bridge, the geometry of the collapsed structure, the secondary damage to the abutments Bed was already being significantly eroded. And piers, the positions in which bearing blocks were found after the collapse and the scour marks on the bridge bearing plates were all consistent with the sequence of collapse triggered by the initial collapse of the downstream end pier 3.

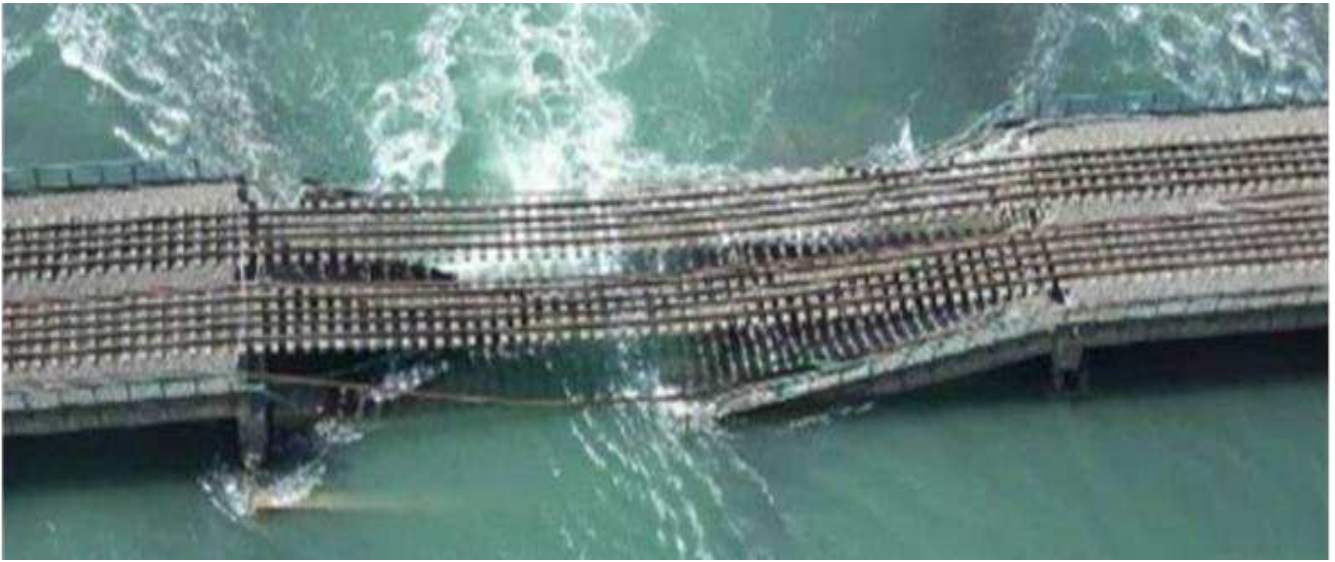
Fig 3: Malahide Viaduct Collapse [20]

On 21 August 2009, pier number 4 of Malahide viaduct collapsed into the estuary as shown in Fig. 3. This viaduct carries the main line between Dublin and Belfast. The investigation was carried out by the Railway Accident Investigation Unit (RAIU) [20]. The collapse was reported by the driver of a train that passed over the damaged viaduct but fortunately crossed immediately before complete collapse occurred.

Detailed investigations were able to prove that the masonry piers of the viaduct were built on top of a stone causeway that acted as a weir. This causeway was maintained in a fair condition for over 100 years by a regular regime of replenishment of the stones, although during that period the causeway elongated seaward due to migration of the stones. In 1967, a major grouting scheme was undertaken to fill voids in the weir. This scheme was reasonably successful but more stones were discharged to fill scour holes on a number of occasions up until 1996.

- i) The long term gradual elongation of the weir in the ebb tide direction (eastwards);
- ii) The medium term degradation and partial removal of the 1.5m thick layer of grout that extends 1.5m in the flood tide direction (westwards) and 6.1m in the ebb tide direction (eastwards). The propagation of scour to the grouted rock armour weir continued in a westerly direction and was concentrated in between Piers 3 – 5.
- iii) The losses were most severe in between Piers 4 and 5. The concentration of flow in this area resulted in a positive feedback mechanism that increased scour depth and allowed further propagation of the hydraulic jump in a headward direction (westwards);
- iv) The short term propagation of the hydraulic jump, resulting

in substantial removal of the grouted and non-grouted rock armour weir material in between Pier 4 and Pier 5 which resulted in the hydraulic jump migrating to a position westward of the bridge piers. The undermining continued in the manner until the invert between piers No 4 and No 5 collapsed, at which time the scour began to undermine pier 4 until it failed.

- v) The grouted layer, which was about 1500 mm thick, acted as an invert but, as scour occurred at the seaward side of the causeway on the ebb tides, this became undermined. The undermining continued in the manner until the invert between piers No 4 and No 5 collapsed, at which time the scour began to undermine pier 4 until it failed.

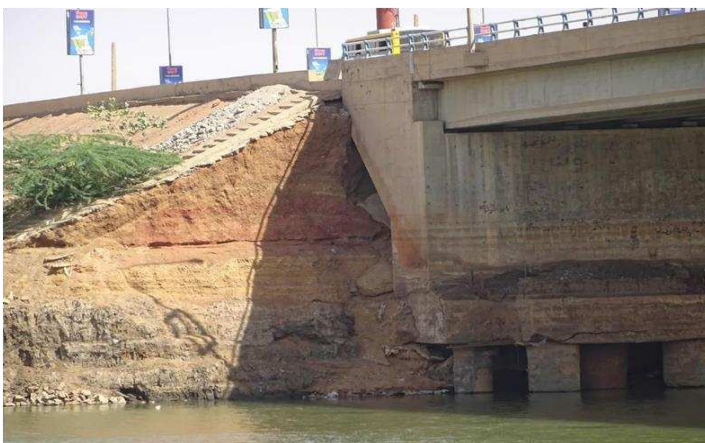
In the year 2015, the flood rate increased to a level more than the normal which lead the soil to wash out around the east abutment as shown in Fig 5. The embankment collapsed due to shear forces on the soil. The piles of the foundation appeared and the soil was washed out around them as shown in Fig. 6. By the end of the autumn season, the embankment around the abutment was completely exposed and the water flow around the piles. Excessive settlement developed in the abutment and the embankment soil escaped down the approach slab as shown in Fig. 7. This situation posed a serious danger to the vehicles and users life on the bridge.

Fig 5: Excessive scouring occurred around the east abutment

The investigation shows that heavy floods in Blue Nile River caused scour which extended gradually over time below foundation level. The bridge did not collapse during the high flood period but on receding floods when a heavy tanker passed over the bridge abutment it's approach slab settled and gone way.

- It is recommended that the urgent and necessary maintenance work to start in the summer season where the water level in river is low. Use rock protection for the embankment and river bed around the abutment.

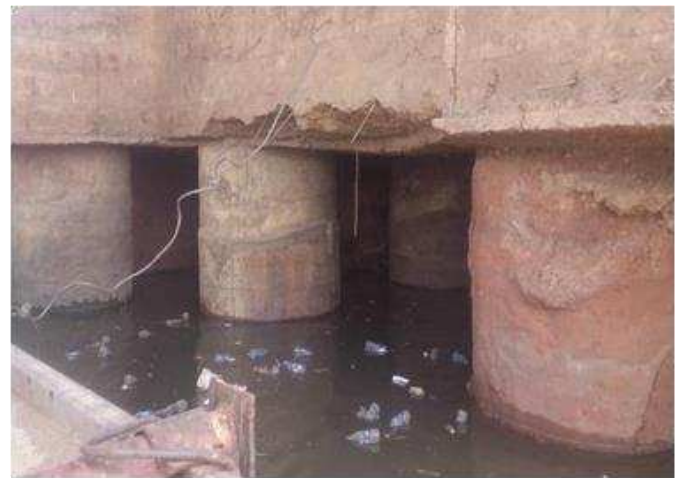
Fig 6: The foundation piles surrounded by water

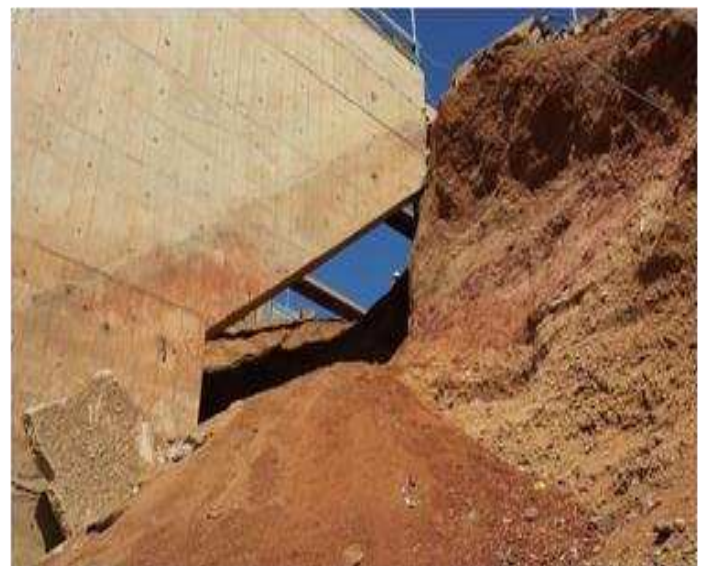
Fig 7: Embankment soil escaped away from the approach slab

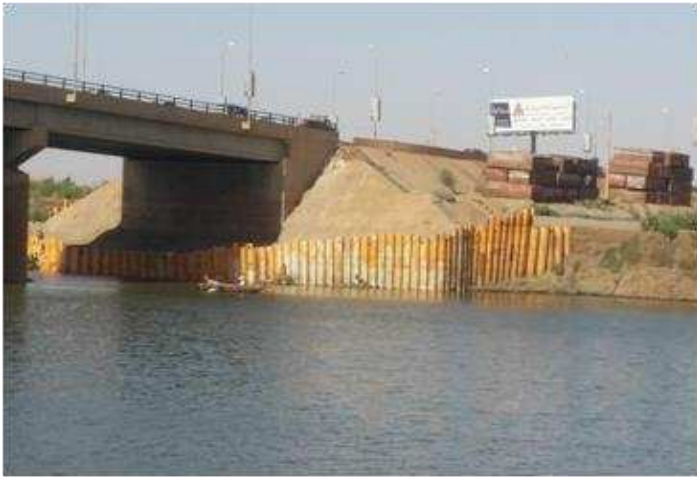
Fig 8: Sheet pile installed around the abutment

In Oct. 2014, the ministry of infrastructures decided to maintain the fail abutment. The maintenance started by driven sheet piles inside and around the abutment to carry the approach slab and providing protection for the new embankment. Landfill works of the embankment took place under the approach slab which was protected by Granite stones and covered with a new asphalt layer on the roadway as shown in Fig. 8.

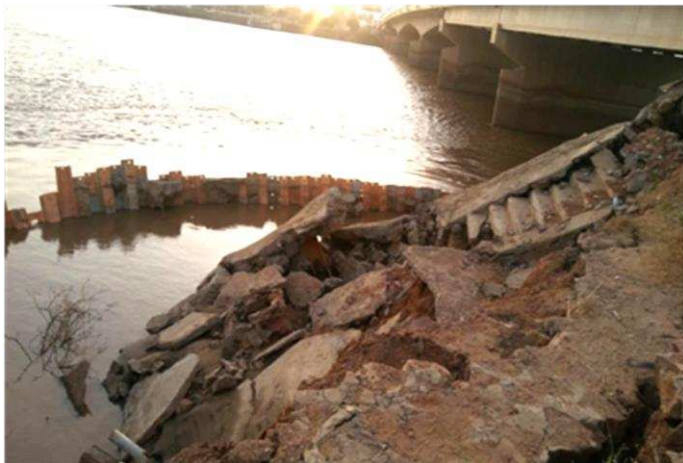
In this research, the bridge was visited to inspect the current situation of the bridge. It was observed as shown in Fig 9 serious failure and damage occurred in the protection made around the east abutment. As can be observed in Fig, complete collapse of the embankments and severe failure happened in the sheet piles surrounding the abutment.

Fig. 9. Serious failure and collapse of the protection around the abutment

- High Speed flow of Blue Nile river water.
- Since the loose soil scoured with high rate and from the result of the sample which had low plasticity.
- Neglect seasonal inspection and periodic maintenance.
- Taking decision of constructing structures around river without any study it's risk to the hydraulic structures.

- Linked to the poor condition of Manshia bridge abutment, the water scouring is the main factor of embankment failure. The lack of embankment protection is a reason that contributes to faster deterioration of the embankment.
