## Investigating Pipe Culvert Failure in Baleela Oil Field in Sudan

**Abstract:** This paper thoroughly investigates failure cases of the constructed pipe culverts in Baleela oil field in west of Sudan. The paper provides technical recommendations and remedial measures. Common types of failures of pipe culverts and their appropriate measures were briefly discussed. The paper provides inspection based on extensive site survey and data record review to find out the main structural and hydrological causes of culverts failure. The site survey is conducted in the last two years while the data record review extended since 2011. The pipe culverts engaged in this study were 20 water streams each of them contain 3 to 8 pipe culverts. Failures of pipe culverts constructed in 9 locations during the last 9 years were evaluated in percentage. The investigation showed that various reasons caused failures of the studied culverts including volume of water flow, corrosion and scouring, floating trees and deformation in pipe culvert obtained from traffic load beside construction related reasons such as culverts assembly, poor construction, un-compacted backfilling and the backfilling soil type in a

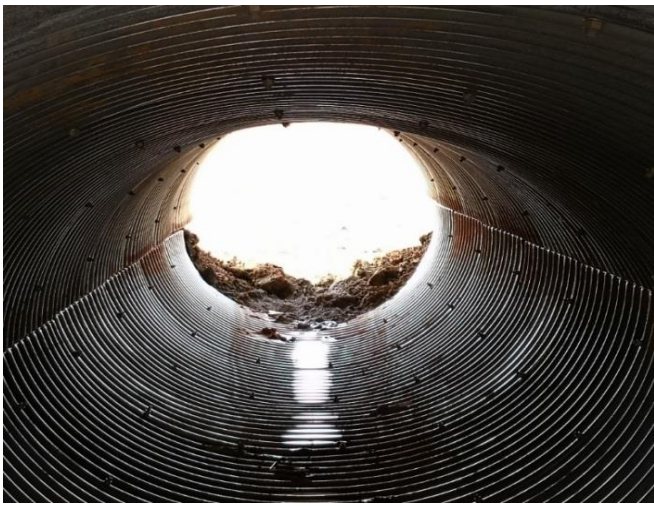
Failure of pipe culvert may occur due to deformation of pipes (Figure 2) which results from load of transportation. Such failure occur when the soils above pipe culvert are not capable to support transportation loads. Soils above pipe culvert should have suitable strength and compaction and should be of thickness not less than 30cm. thickness above pipe culvert depending on pipe diameter. Larger pipes require larger thickness.

**Fig .3.** Deformation in pipe culvert in Shag Yahia

To avoid deformation of pipe culvert such as that shown in figures 2 and 3 backfilling soils above the pipe culvert should be of thickness of at least 300 mm. Thickness of soil above the pipe culvert depends upon the pipe diameter. The larger diameter pipes requires larger thickness of soil above. Erosion protection (stone pitching) is recommended to avoid scouring. Construction of stone pitching protect the embankment on both inlet and outlet. However, long-lasting stability of pipe culverts can be assured.

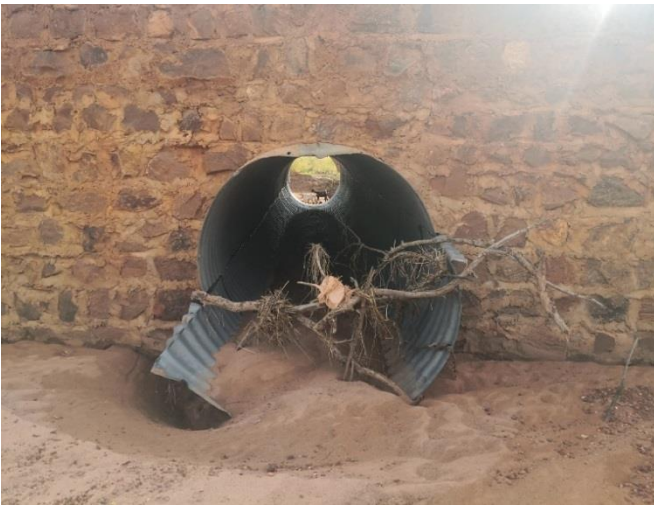
Capacity related failures of culvert in some cases is accelerated by floating trees that blocks the inlet of culvert in some cases which cause high pressure. Figure 4 shows floating trees in culvert in Baleela.

**Fig. 4.** Floating tree in pipe culvert inlet in Sabreen

Annual remedial maintenance of pipe culvert is recommended. Annual maintenance is recommended particularly before rainy season starts. Lack of maintenance likely increases the failure possibility of pipe culverts. Floating trees which stuck in the inlet of pipe culvert should be removed promptly.

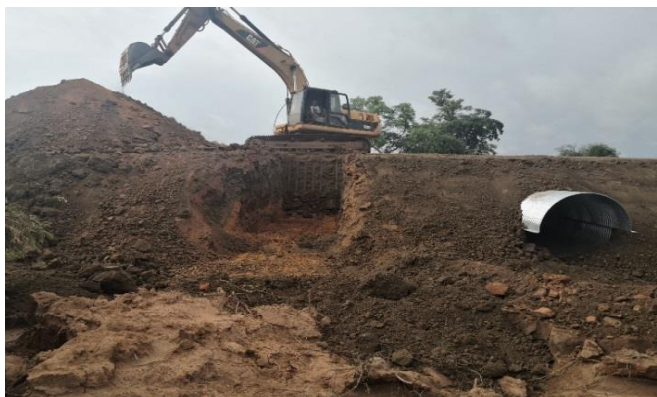
**Fig .7.** Pipe culvert installation in BNA road

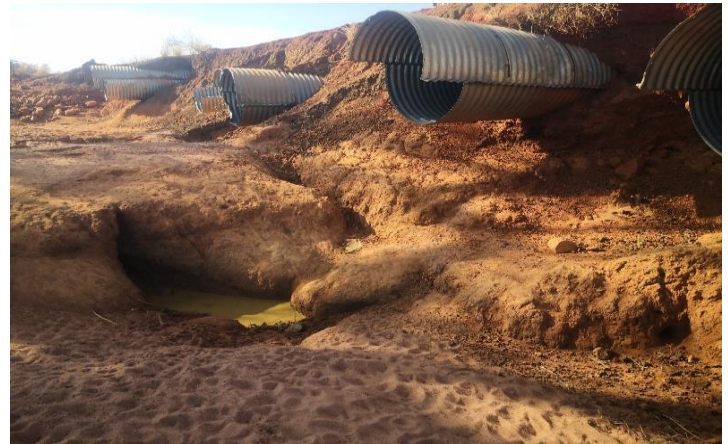
**Fig .8.** Erosion in the outlet in Sabreen

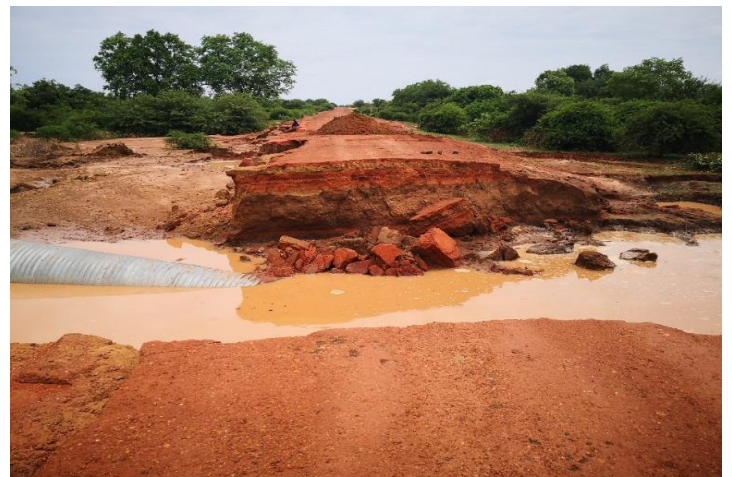
**Fig .9.** Erosion of soil due to pipe culvert failure in BNA road

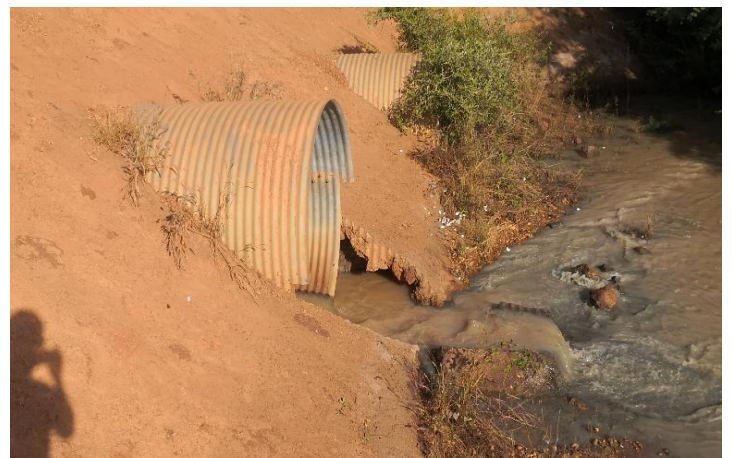
Lately erosion protection made of stone pitching (Figures 4 and 10) were constructed in some pipe culvert locations to minimize erosion and to protect embankment. Stone pitching are used to construct walls, wing walls and aprons on both inlet and outlet. The stone pitching served well in the first 4-5 years. Beyond that they needed remedial maintenance due to high water pressure (Figure 10). It was noticed that walls of stone pitching were affected from the water flow on upper streams further than down streams. While aprons of stone pitching were affected further down streams due to hydraulic jump.

**Fig 10:** Erosion in protected pipe culvert in HTL road

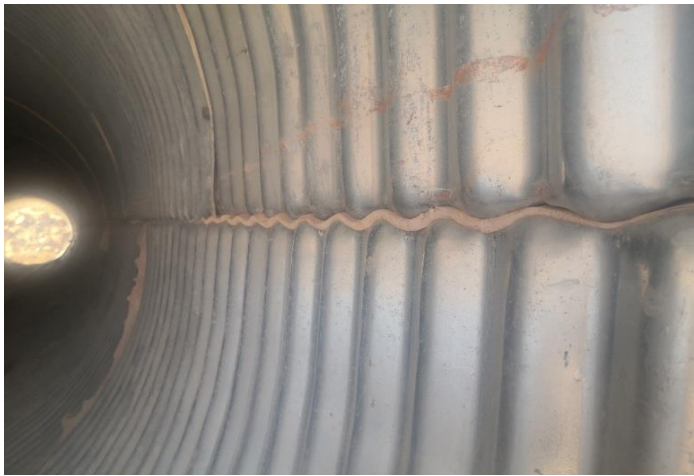
Before 2014, road construction supervisors detected some failures on pipe culverts were caused by water seepage through the connection of pipe culvert's sheets. The sheets made of metals are only connected together by 4 to 5 bolts. Rubbers sandwich were suggested to ensure proper connections of sheets and to prevent water seepage. The rubbers which depicted in figure 11 were made of plastic sheets of 10cm width and length as pipe culvert sheets. The rubbers which have adhesive on both sides sandwiched between individual sheets. It was reported that the new techniques remarkably reduced failure on pipe culvert caused by water seepage.

Fig. 11. Rubber sheets sandwiched in pipe culvert in BV#2 KP7.

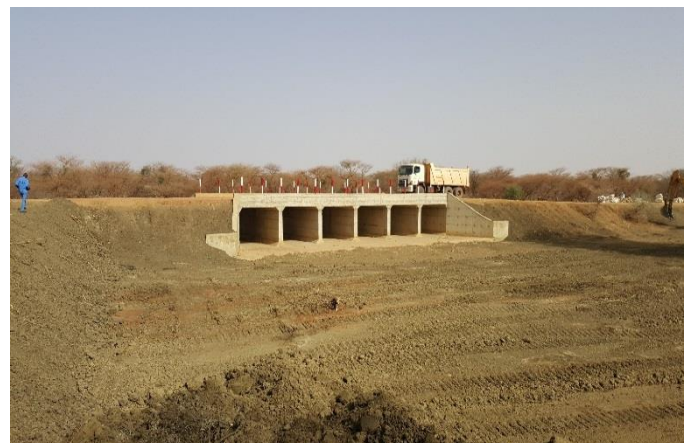
**Fig.22.** 6 cells concrete box culvert in HC pipeline road

Further hydrological studies to determine water flow volume on valleys help to select certain crossing structures along with selecting adequate size of pipe culvert. Pipe culverts are not suitable for very high water flow volume. For such purpose concrete box culvert as that depicted in figure 22 would be the recommended choice.
