# Importance of Deep Excavation Support and Its Influence on Adjacent Buildings

**Abstract:** This paper aims to investigate the important role of deep excavation support and its effect on nearby existing buildings, especially those founded on shallow foundations. Excavation of basement or foundations induces movements as a consequence of stress-release from earthwork and an increase in overburden pressure in the retained ground. Ground movements throughout excavation result in damage to existing structure located nearby. An intensive literature of previous experiences on supporting deep excavation and their impact on neighboring structures reviewed. This paper presents three case histories and two local current cases of excavations, which caused damages either on their own projects or on adjacent buildings. The results revealed that there are numerous sources of risk associated with performing deep excavations in urban areas, they must be considered in the design and execution of the excavation works for a minimum cost. General conclusions have been drawn from the study findings.

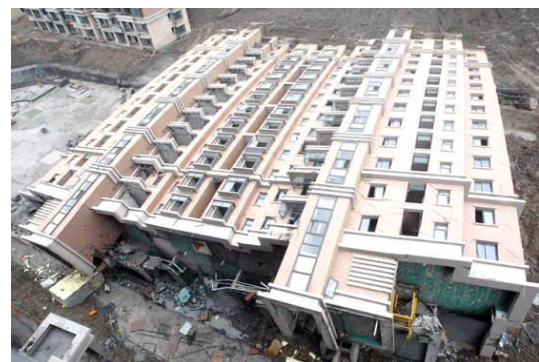
**Fig. 2** Building Collapsed in Shanghai, [6]

under construction at Lian huanan Road in Min hang district of Shanghai city collapsed. It was reported that one worker was killed. The collapse was caused by the deep excavation of 4.6m made for an underground car park alongside the building, being piled to depths of up to 10 m on the other side of the structure. The weight of the pile created a pressure differential which led to a shift in the soil structure, eventually weakening the foundations and causing them to fail (see Fig. 2). This situation may have been aggravated by several days of heavy rain leading up to the collapse. Improper construction methods are believed to be the reason of building collapse, according to the investigation team report, [6]. They stated that workers dug an underground garage on one side of the building while on the other side earth was heaped up to 10m high, which was apparently an error in construction.

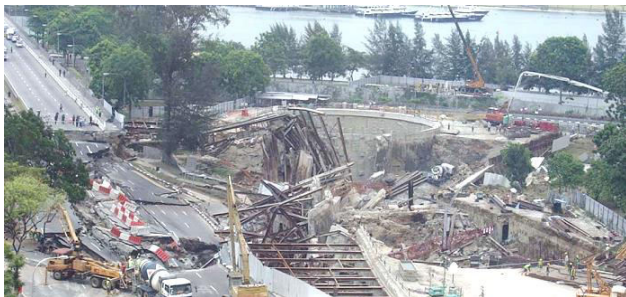
accident left a collapse zone 150 m wide, 100 m long, and 30 m deep. As can be seen in Fig. 4, Steel beams were twisted, with two construction cranes being swallowed up. A substantial chunk of the main highway running over the tunnel was also knocked out. All six lanes of the Nicoll Highway were heavily damaged, rendering the road unusable. A committee of inquiry found main contractor Nishimatsu Construction Company and its officers as well as Land Transport Authority officers responsible for the collapse. As a result of the accident, Stages 1 and 2 of the Circle line were delayed. The partially built station structure was abandoned, and the affected station has been shifted about 100 m away from the accident site. Eventually, Nicoll Highway station started operations on 17 April 2010.

**Fig. 4** Collapse of Nicoll Highway at MRT Station in Singapore, [7]

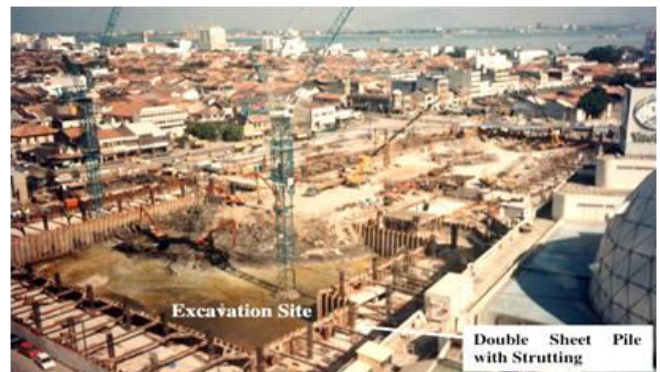
A Basement Excavation in Penang is a case history of a shopping mall with proposed two levels of basement. A 15m deep double sheet pile walls supported by internal struts acting as a temporary coffer dam had been completed, [8]. Forty percent of the plan area of excavation reached a general depth of 7m except at certain locations for lift pits where the excavation reached a depth of 10m. Fig. 5 shows the site condition upon reaching the final excavation level and Figure 5 shows a typical section of the temporary sheet pile wall installed at the site. The plan area involved approximately 20,000 m<sup>2</sup>. Before the basement slab was cast at the site, hydraulic failure had already taken place and water flow into the clayey subsoil at the base of the excavation pit was evident. The continued pumping out of the water from the pit unknowingly by the contractor caused significant drawdown in the groundwater in the surrounding retained ground. The lowering of the groundwater in the retained ground induced significant settlement (both immediate and consolidation) resulting in large cracks and differential settlement of the pre-war (1930+) houses that were supported by shallow block foundation with or without one length (4m to 5m) of bakau piles. On complaints from the residents of the affected houses, the Local Authority ordered the project to be stopped pending investigation.

Significant damage was clearly visible to the surrounding 300 houses though some houses were more than 300m away from the retaining wall.

**Fig. 5** The Site Condition of Penang upon Reaching the Final Excavation Level [8]

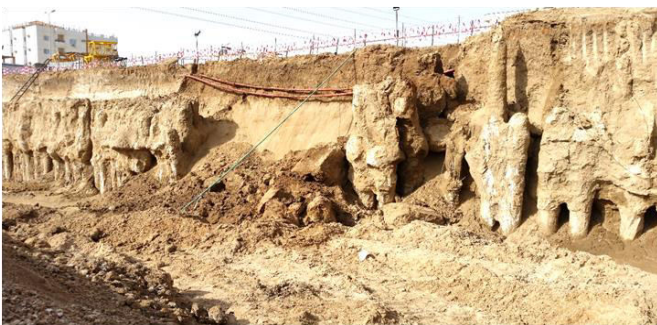
As per design, excavation should be carried down to 8 m depth. Before any excavation, the contractor decided to do shoring system using 50 cm bored, cast in situ piles with 8 m length starting from 5 m depth. 13 m holes were bored and then the reinforced 8 m piles were casted. Due to undefined well-shoring item in the bill of quantity and not giving any attention but to ground water table and the dense soil layers, the consultant and the contractor with confidence did the shoring piles distributed all around the perimeter with different gaps in between reach to more than 1 meter in some places as shown in Fig. 7.

**Fig. 7** The shoring piles distributed all around the perimeter of the building basement

- Not giving more attention to the geotechnical report, which clearly mentioned the 6 m perched water and the intermediate layers of sand.
- Cast the shoring piles without adequate control, making their additional cantilevers suffering without any reinforcement.
- Cast the piles with gaps in between let this mater to be amplified.

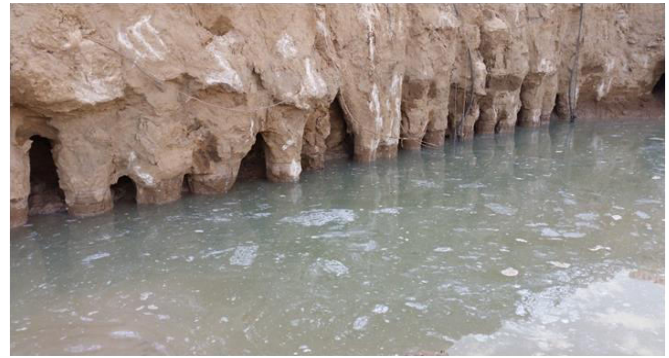
The contractor started to excavate for the basements. When the excavation reach close to 6m depth, water started to appear from all directions, filling the site and erode the sand layer at that level creating cavities behind the piles and beneath the top dense soil. At the same time many piles appeared to be casted more than their planned length.

To collect the flowing water, the contractor decided to excavate trenches in front of piles all around the perimeter and start dewatering (4 to 10m<sup>3</sup>/hr. – 20 hrs./day pumps). Due to sand layer at 6 m depth, piles concrete compressed the sand and created necks at that level. These necks allocated inside the line of basement retaining walls. When the excavation reached this level, 11 piles in the eastern side had been sheared and fall down letting an approximately 1m wide of supported soil collapse.

**Fig. 8** Subsurface Water Filling the Site and Erode the Sand Layer Creating Cavities behind the Shoring Piles.

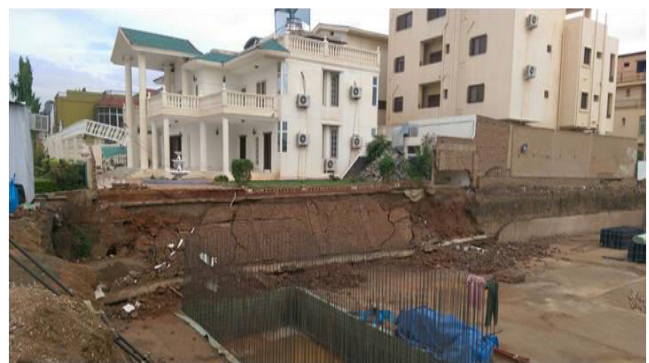
The project is a residential building at Kafoori in Khartoum North. The building is a multi-story with a basement. The contractor excavated all the area of the plot for a depth of 4.1m, keeping 90cm between the building and the western neighbor building. During the foundation processes, the attached compound wall for this neighbor collapsed as shown in Fig. 9.

**Fig. 9** The Shoring Piles Distributed All Around

The case took a liability path and the work stopped for a while till the situation had been settled and the contractor erected a temporary fence with a commitment to erect the compound wall on his charge.
