## Effect of Excavation Dewatering on Adjacent Structures

**Magdi M. E. Zumrawi, Elhaytham Hassan**

**Abstract:** The study aims to investigate the effect of dewatering technique on retained ground and adjacent existing structures in order to avoid any damages that may occur. The paper presents three cases of potential structure failure caused by ground settlement as a result of dewatering. Two current construction projects in Khartoum North were selected as a case study. The two projects are located near Blue Nile River where ground water table exists at shallow depths. Dewatering to reduce the groundwater level was carried out in the two sites to facilitate excavation works. The buildings and road pavements around the two sites suffered serious damages due to excessive differential settlements of the retained ground. The study results showed that there are numerous sources of risks associated with performing dewatering. Therefore, developing appropriate plan for dewatering before construction is essential to mitigate any adverse impacts and avoid risks.

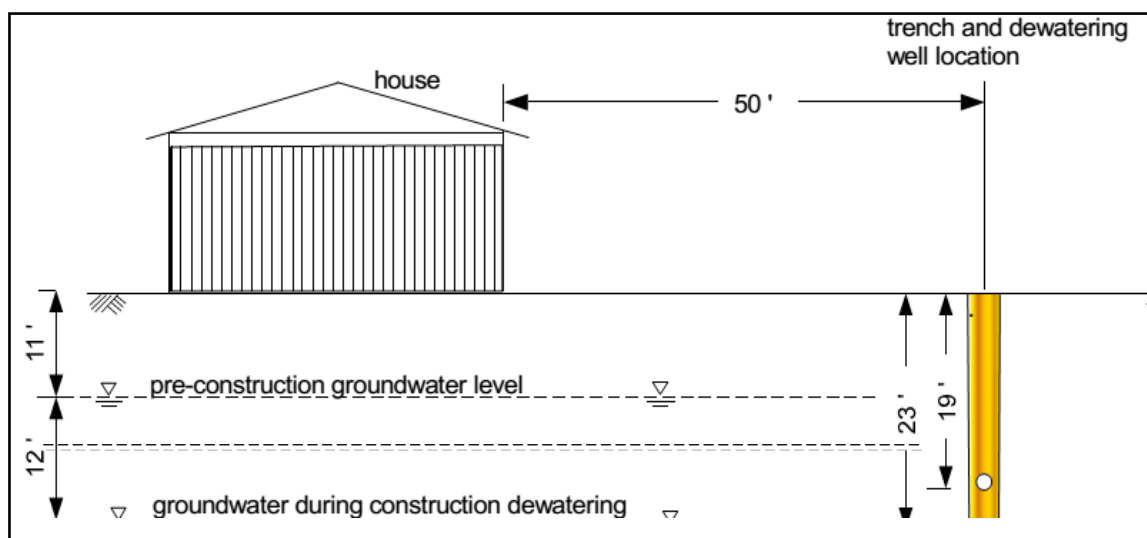
to provide clearance for pipe bedding gravel. The construction plans and specifications required that all work in the trench be conducted in the dry, including placement of the pipe bedding gravel and installation of the sewer pipe. Consequently, because of the presence of groundwater, dewatering was required during trenching and pipe installation. The structure influenced consisted of an approximately 24.4 m<sup>2</sup> (2,200 ft<sup>2</sup>) one-story wood house with a finished basement. This house was the closest structure to the trench and the contractor's primary dewatering well. The trench was excavated approximately parallel to the long axis of the house, about 15 m (50 ft.) from the back wall. The dewatering well was located about the same distance from the house as shown in Figure 2. Numerous irregularities in the interior of the subject home occurred, including drywall cracks in the ceiling, walls, and in many of the wall ceiling joints.

Currently available scientific methodologies and analytical methods indicate that the subject residence experienced damaging settlement as a result of groundwater lowering caused by nearby construction dewatering [13].

Fig. 2. The trench and dewatering well location at the project site, [13]

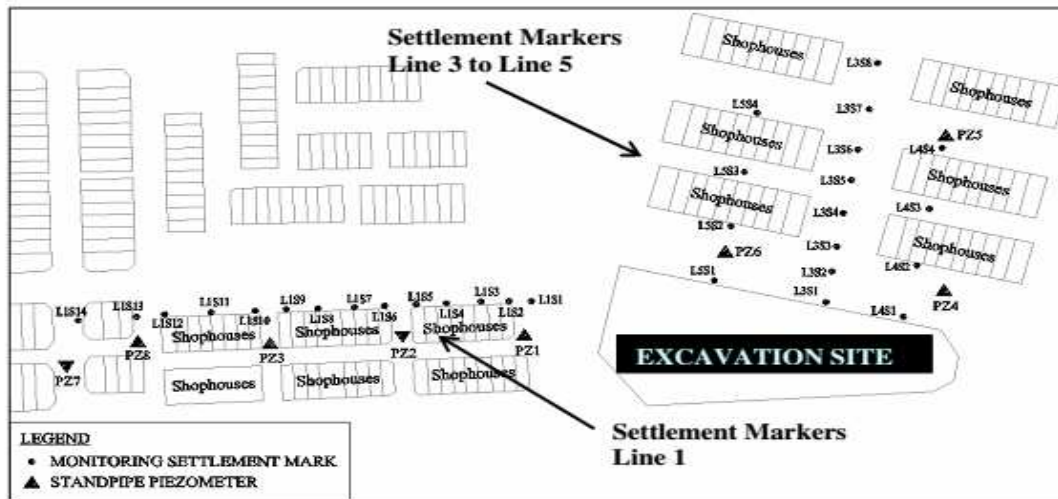
A case of structure collapse event due to dewatering occurred in Malaysia, [14]. The project is a basement excavation in Sarawak Malaysia. Many three-story shop houses surrounding the project site which have suffered cracks and significant settlement of the apron slabs and drains. These shop houses are supported by bakau piles (a type of natural wood piles). The excavation site surrounded by many shop houses with settlements markers lines are shown in **Fig. 3**.

**Fig. 3.** The project excavation site surrounded by many shop houses, [14]

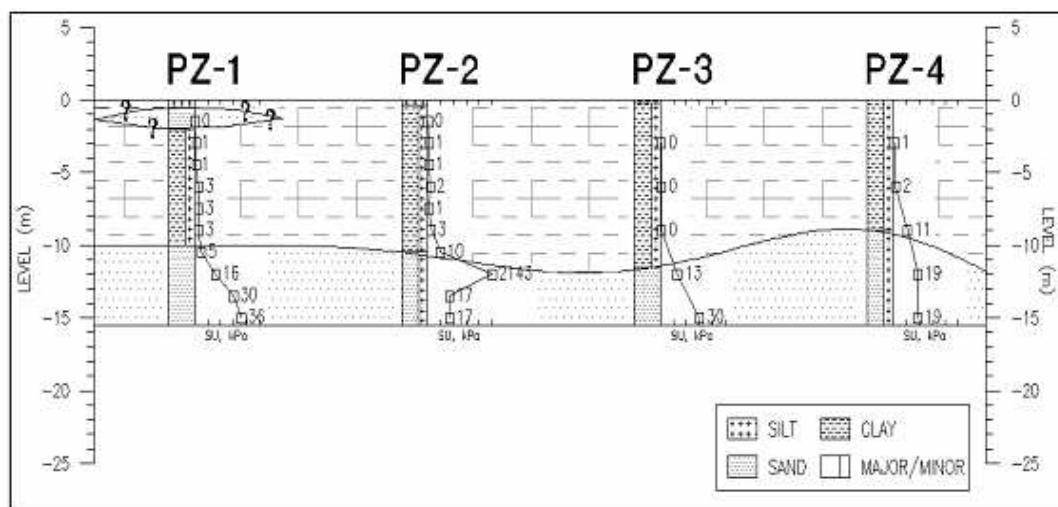
the site consisted of 10 to 12 m of silty clay underlain by sandy soil, the thickness of the cohesive layer decreased towards the proposed basement excavation site indicating that sandy materials are at the shallower depth of the excavation site. For PZ-1 area, the estimated original groundwater level prior to the excavation ranged from about 1 to 2 m below ground level.

**Fig. 4.** Subsoil profile of Sarawak site, [14]
