## Investigating Pipe Culvert Failure in Baleela Oil Field in Sudan

**Abstract:** This paper thoroughly investigates failure cases of the constructed pipe culverts in Baleela oil field in west of Sudan. The paper provides technical recommendations and remedial measures. Common types of failures of pipe culverts and their appropriate measures were briefly discussed. The paper provides inspection based on extensive site survey and data record review to find out the main structural and hydrological causes of culverts failure. The site survey is conducted in the last two years while the data record review extended since 2011. The pipe culverts engaged in this study were 20 water streams each of them contain 3 to 8 pipe culverts. Failures of pipe culverts constructed in 9 locations during the last 9 years were evaluated in percentage. The investigation showed that various reasons caused failures of the studied culverts including volume of water flow, corrosion and scouring, floating trees and deformation in pipe culvert obtained from traffic load beside construction related reasons such as culverts assembly, poor construction, un-compacted backfilling and the backfilling soil type in a

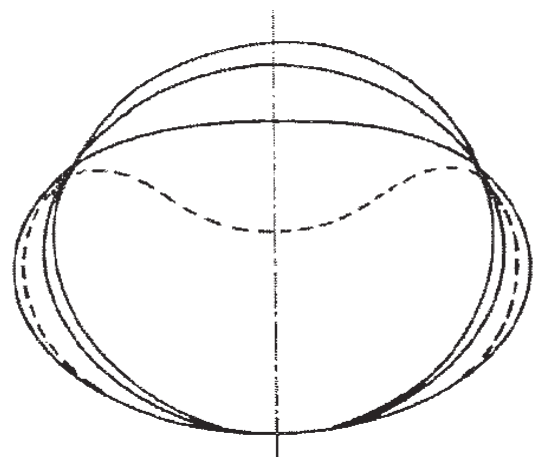
Failure of pipe culvert may occur due to deformation of pipes (Figure 2) which results from load of transportation. Such failure occur when the soils above pipe culvert are not capable to support transportation loads. Soils above pipe culvert should have suitable strength and compaction and should be of thickness not less than 30cm. thickness above pipe culvert depending on pipe diameter. Larger pipes require larger thickness.

Fig. 2. Stages during deformation of a flexible culvert [8]

To avoid deformation of pipe culvert such as that shown in figures 2 and 3 backfilling soils above the pipe culvert should be of thickness of at least 300 mm. Thickness of soil above the pipe culvert depends upon the pipe diameter. The larger diameter pipes requires larger thickness of soil above. Erosion protection (stone pitching) is recommended to avoid scouring. Construction of stone pitching protect the embankment on both inlet and outlet. However, long-lasting stability of pipe culverts can be assured.

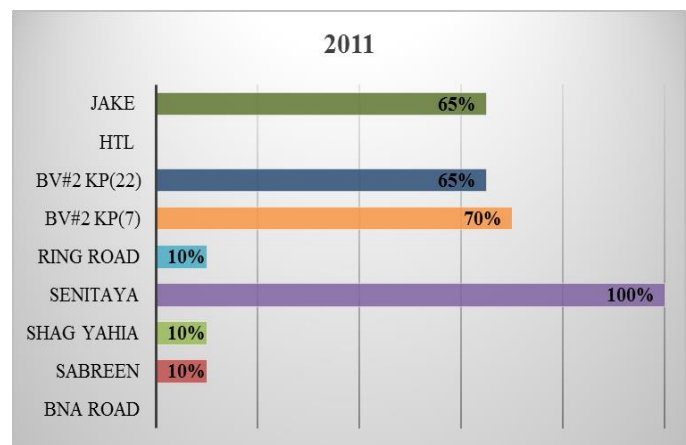
Fig.12. Failures in some pipe culverts in 2011.

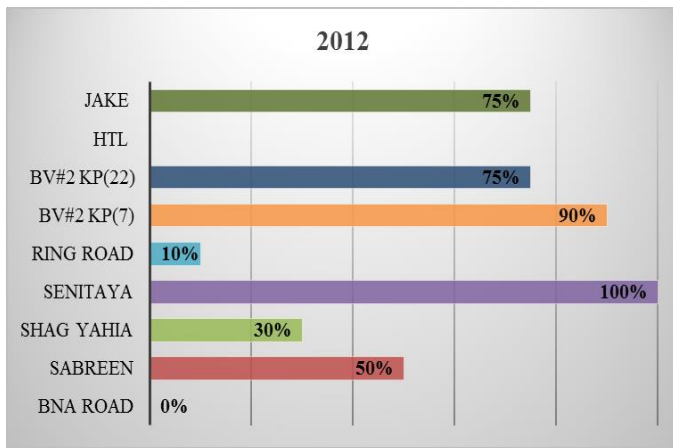
**Fig .13.** Failures in some pipe culverts in 2012

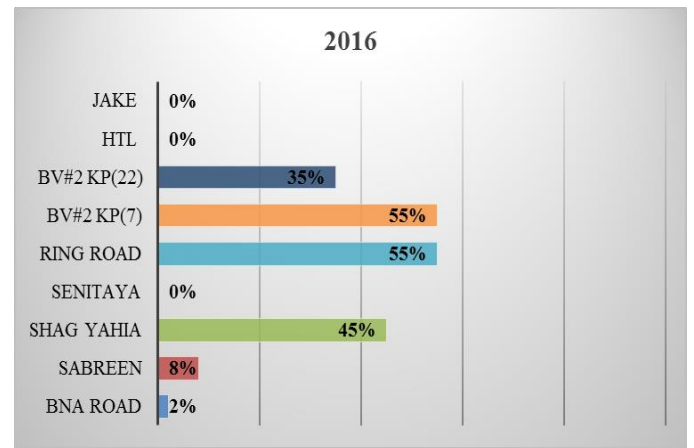
**Fig .17.** Failures in some pipe culverts in 2016

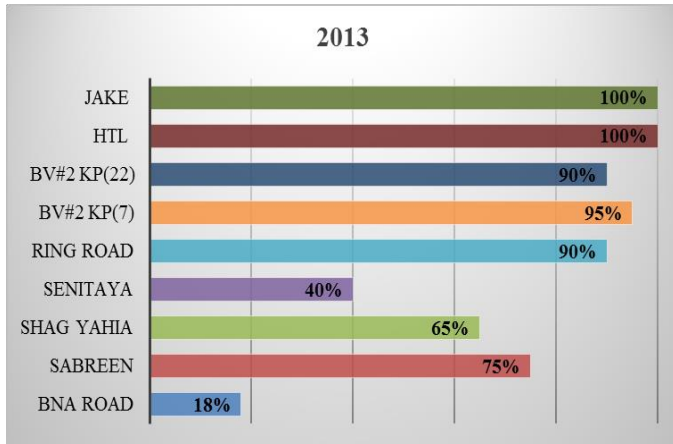
It was noticed that most failures in pipe culverts occurred in 2013 as shown in figures 14 and 21. According to Sudan Meteorological Authority data 2013 recorded the most rain fall in Sudan compared with the latest years up to 2008. Additionally some practical techniques including rubber sheets were not used yet. Many roads and highways around Sudan were damaged and closed at least for a while in 2013. In Baleela in 2013, two main roads (Jake and HTL roads) were totally closed for more than a month due to serious failure in pipe culverts (100% failure) beside three other main roads were closed due to serious damages in pipe culvert (90% failure).

**Fig .14.** Failures in some pipe culverts in 2013

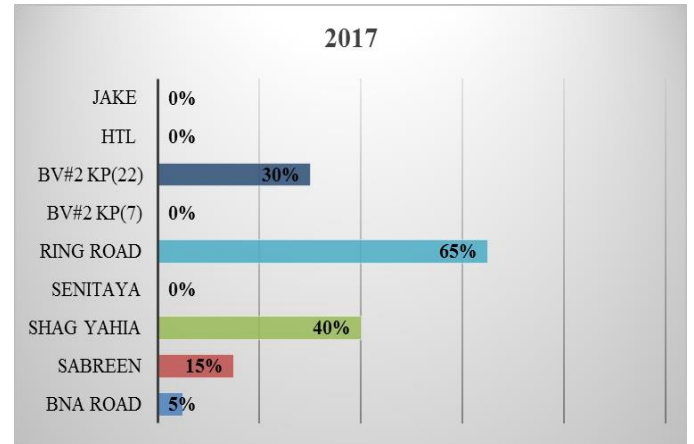
**Fig .18.** Failures in some pipe culverts in 2017

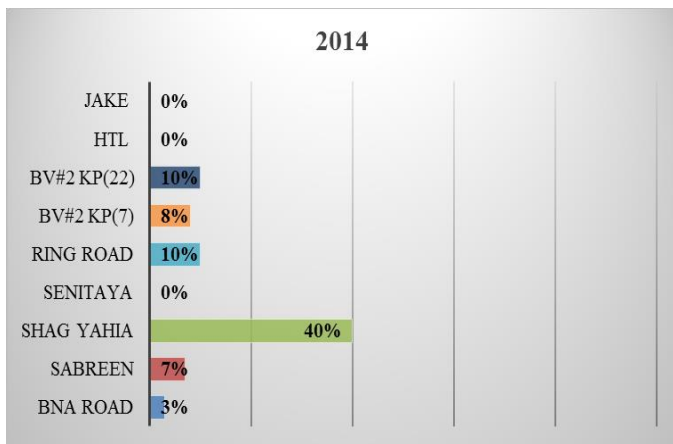
It was observed that remarkable improvement in pipe culverts performance during 2014 subsequently gradient deterioration in performance was noticed after 2014. Construction of concrete box culvert in earlier 2014 in some locations replacing the pipe culvert showed evident improvement.

**Fig .15.** Failures in some pipe culverts in 2014

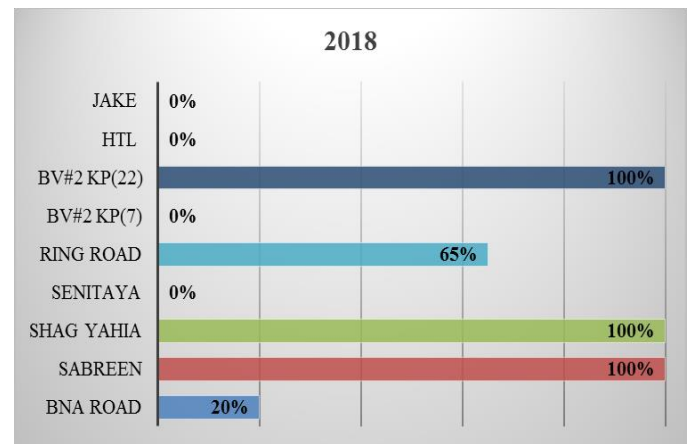
**Fig .19.** Failures in some pipe culverts in 2018

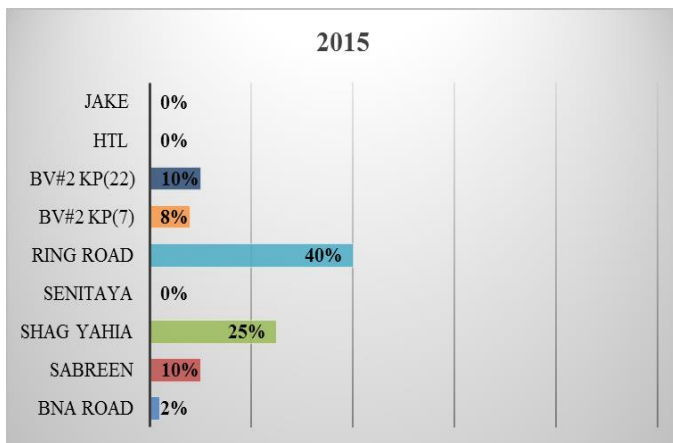
**Fig 16.** Failures in some pipe culverts in 2015

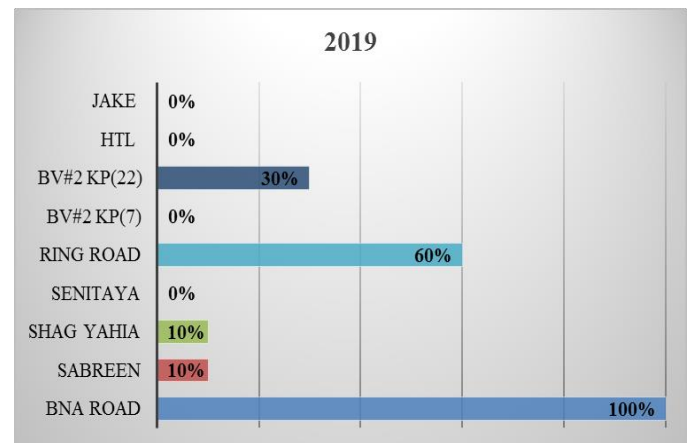
**Fig .20.** Failures in some pipe culverts in 2019

In 2019 an improvement in pipe culverts performance was detected particularly after construction of many stone pitching (erosion protection). Only BNA road was subjected to total damage and the road was closed for a while. After deep investigations, unexpected changes in the surrounding environment were discovered. The changes were made by digging trench on the upstream of BNA pipe culvert for security reasons. The trench was completed near the end of 2018 and it affected the road in autumn in 2019. The road was repaired and stone pitching was constructed in early 2020.

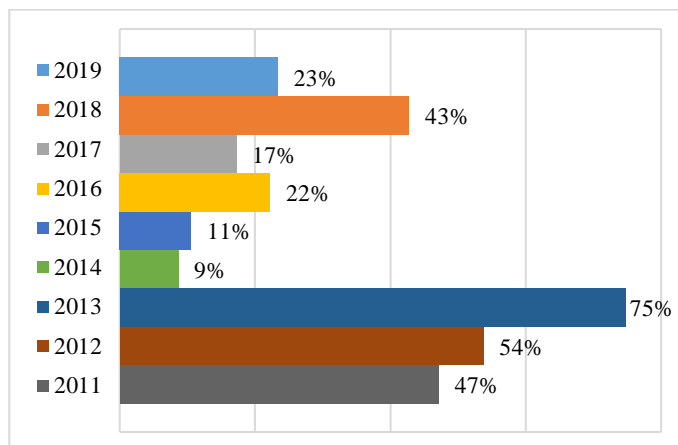
Figure 21 shows annual failure of pipe culvert in the main 9 valleys in percentage. The figure was plotted using the average failures in all valleys each year in percentage. From the figure it can be noted that 2011, 2012 and 2013 were recorded the most horrible failures of pipe culvert compared with other concerned years. Remarkable improvement can be observed in 2014 then gentle decrease in performance appeared. In recent 6 years 2018 showed many failures on pipe culverts. 3 main roads were totally damaged and closed (BV#2 Kilo Point 22, Shag Yahia and Sabreen). Failures occurred in those pipe culverts due to high water volume, floating trees and lack of backfilling soils to support pipe culverts. Later in 2019 those pipe culverts were protected using stone pitching.

**Fig.21.** Annual failures of pipe culverts in Baleela in percentage
